408 8th Street, N.W. (National Art
and Frame Company)
Washington, D.C.

HABS No. DC-517

BUILDING DOCUMENTATION

National Art and Frame Company
408 Eighth Street, NW
Lot 811

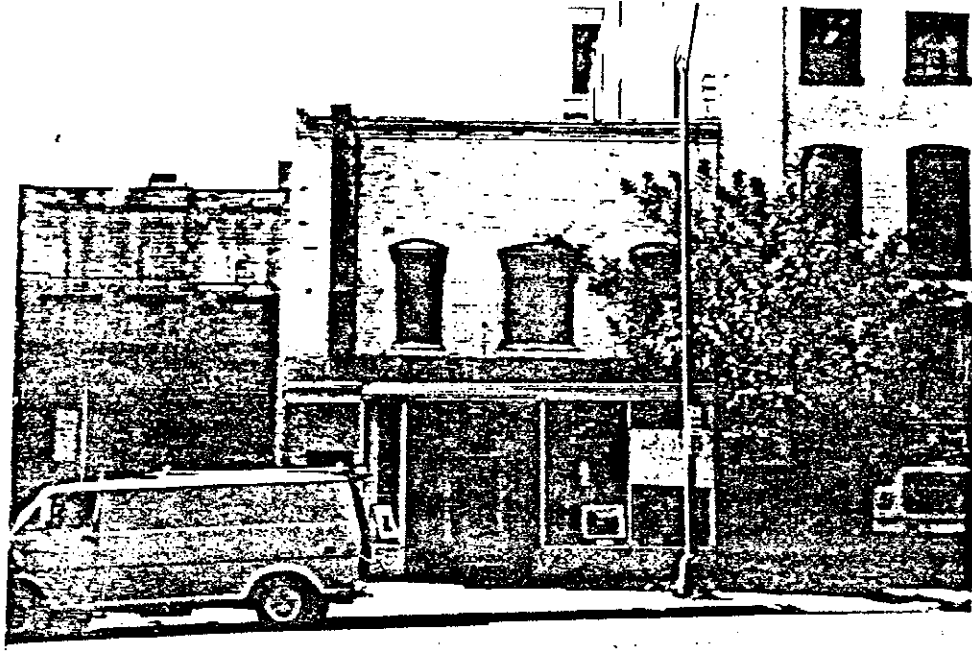
EIGHTH STREET FACADE (EAST)

On the facade, the storefront of this brick structure has undergone considerable alteration. It now consists of a recessed entryway segregating the show-window organization into a two-and-one cluster. It is supported by ceramic tile-clad plinth and features an aluminum fascia above the glazed areas. Highlighting the second level is a tripartite window assemblage. The central window opening is approximately three feet wider than its flanking ones. Each window is crowned with segmental brick arch devoid of ornamentation. The top of the facade features a classical cornice.

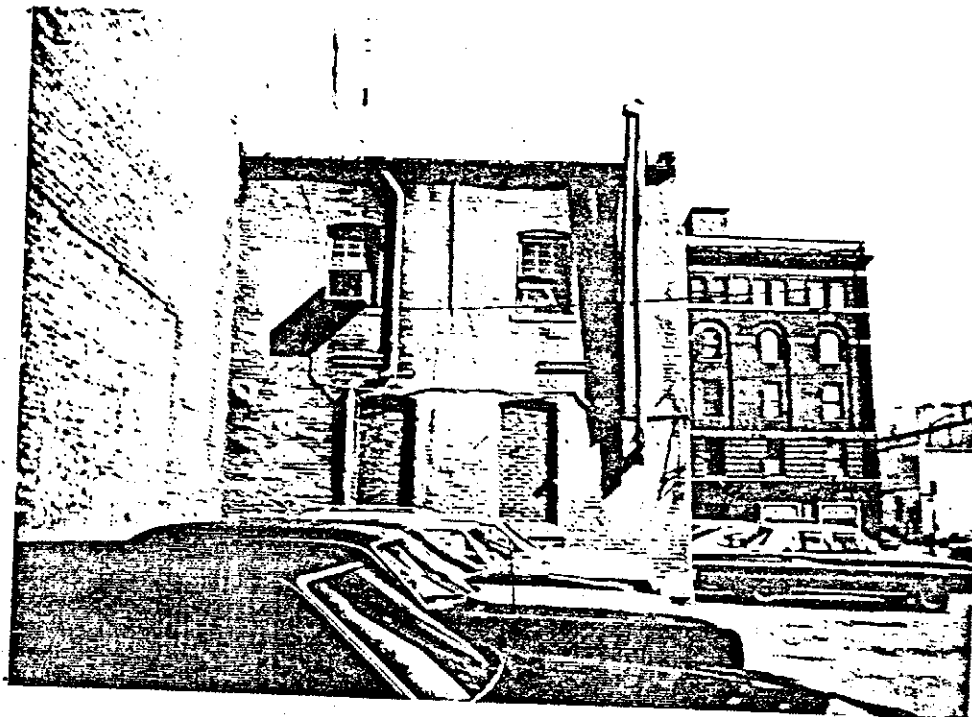
WEST OR REAR ELEVATION

The rear wall is brick, now sprayed with cement. Each level has two segmentally-arched windows. Only one of the whole is proportionally inharmonious: resting on a sill lower than its neighbor, the first floor south window has a more slender vertical proportion than all others. This and cracks on the cement plaster lead us to believe that it was originally a door that provided service access from the no longer existing alley.
